Faro Solar Complex

Redevelopment Pre-Feasibility

FINAL REPORT

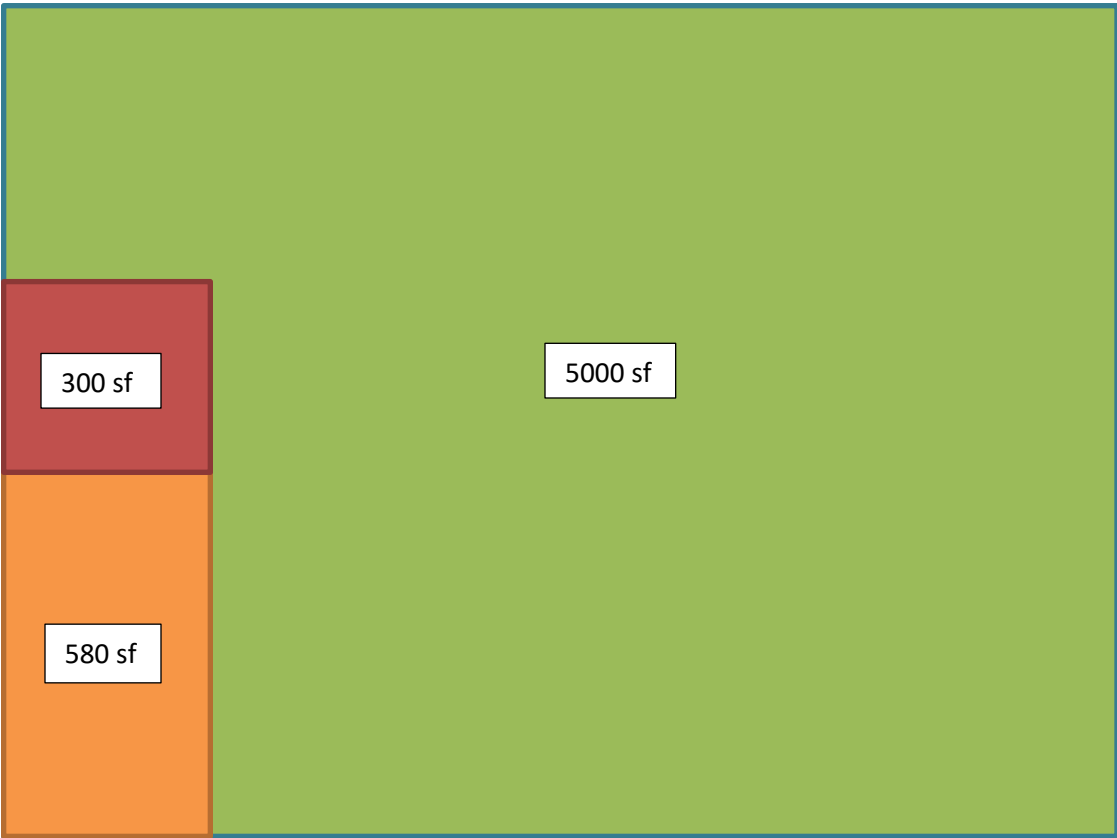
Phase 2 – Rehabilitation and Development of Existing Solar Complex – 5,880 sf

Washroom/Mechanical Room
